# TECHNICAL BULLETIN

## *SC1 & SC2 Splice Coupler*

July 2024

### CABLE SEATING DEPTH

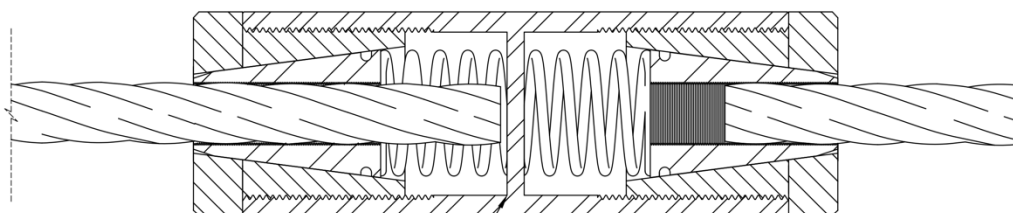
An issue that may arise with inexperienced or inattentive technicians during the installation of the SC1/SC2 Splice Coupler is the failure to fully seat the cable within the wedges. A common mistake is that the installer pushes the cable partially into the wedges, this can give the false impression that the cable is fully seated because the cable “feels tight” when hand pressure is applied. However, the cable will slip from the wedges during tensioning of the tendon.

CABLE IS FULLY INSTALLED, WHICH ALLOWS THE WEDGES TO FULLY ENGAGE. MINIMUM ENGAGEMENT LENGTH IS 2-1/4" FROM SPLICE FACE TO CABLE TIP.

CABLE IS ONLY PARTIALLY INSTALLED IN THE WEDGES. WILL FEEL HAND TIGHT, BUT SLIPS DURING TENSIONING.

INTERNAL MACHINED BAFFEL PREVENTS OVER-PENETRATION OF CABLE.

One of the SC1/SC2 Splice Coupler design features is that it is machined with two individual wedge chambers on each side of the splice that are separated by a solid steel internal baffle. That means it’s physically impossible for the technician to over-penetrate the cable into the opposite side wedges and cause them to become displaced. Therefore, it is recommended that the cable be installed a minimum depth of 2.25” as measured from the face of the splice end cap.

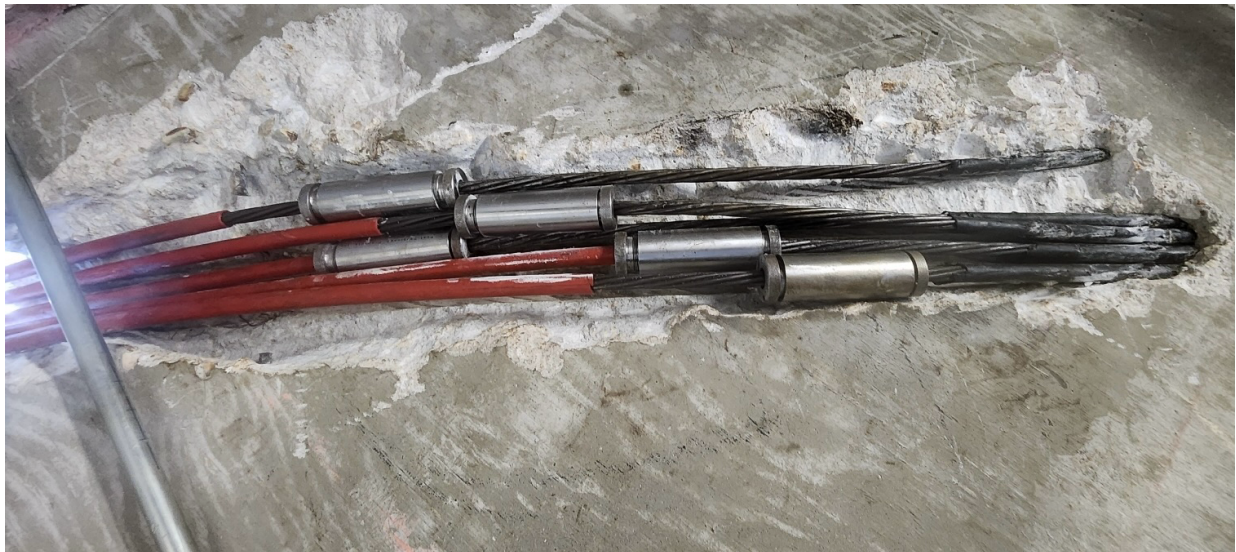
#### **Placement within a lateral tendon sweep**

An issue that can affect both experienced and inexperienced installers during the repair of unbonded tendons is related to the placement of splice couplers in a way that places high bending stress on the hardware. These parts are designed to handle high tension loads that run in an in-line unidirectional manner through the part, and when subjected to off-center excentric tension loads, it can result in a sudden and catastrophic failure of the splice coupler.

This problem occurs during the repair of tendons that have ruptured from a slab as the result of insufficient hairpin reinforcement. Some installers find it tempting to make the repair within the existing damaged area of the slab, where the tendons are making a lateral directional change. It is strongly recommended to avoid the installation of splices within an area of lateral tendon displacement, instead they should be located in areas where the tendons have returned to a straight configuration.

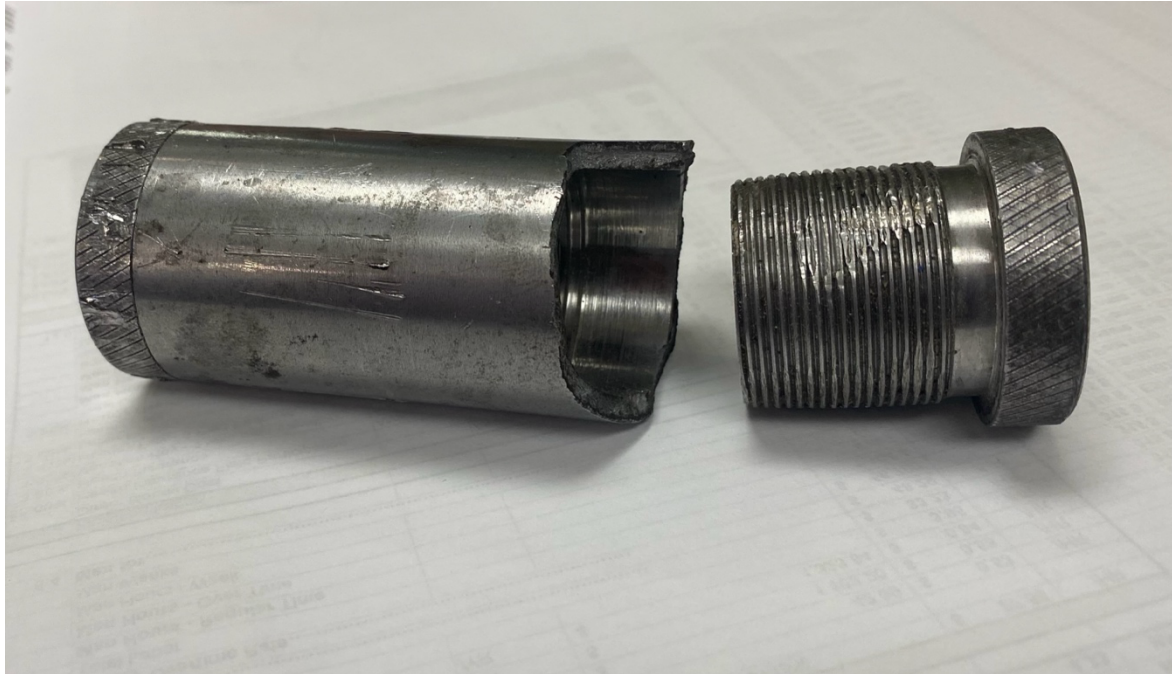
### **Insufficient clearance around the splice coupler**

This issue can develop when splices are installed in a location that causes an out of alignment condition because the splice is prevented from remaining straight due to a hardened obstacle, such as embedded rebar or concrete. During tensioning, the obstacle can cause a high bending stress to develop within the splice coupler, resulting in failure of the hardware. Care should be given to either removing the obstacle or relocating the splice to a location where it can remain in a straight and flat configuration.
